Inspection Report
Minerals Regulatory Program
December 23, 2008

Mine Name: Aurora Clay Mine	Permit Number: S/041/0033
Operator Name: Western Clay Company	Inspection Date: November 25, 2008
Inspector(s): Lynn Kunzler, Wayne Western	Time: 11:45 am
Other Participants: Cory Thurston, Operator	Mine Status: undergoing reclamation

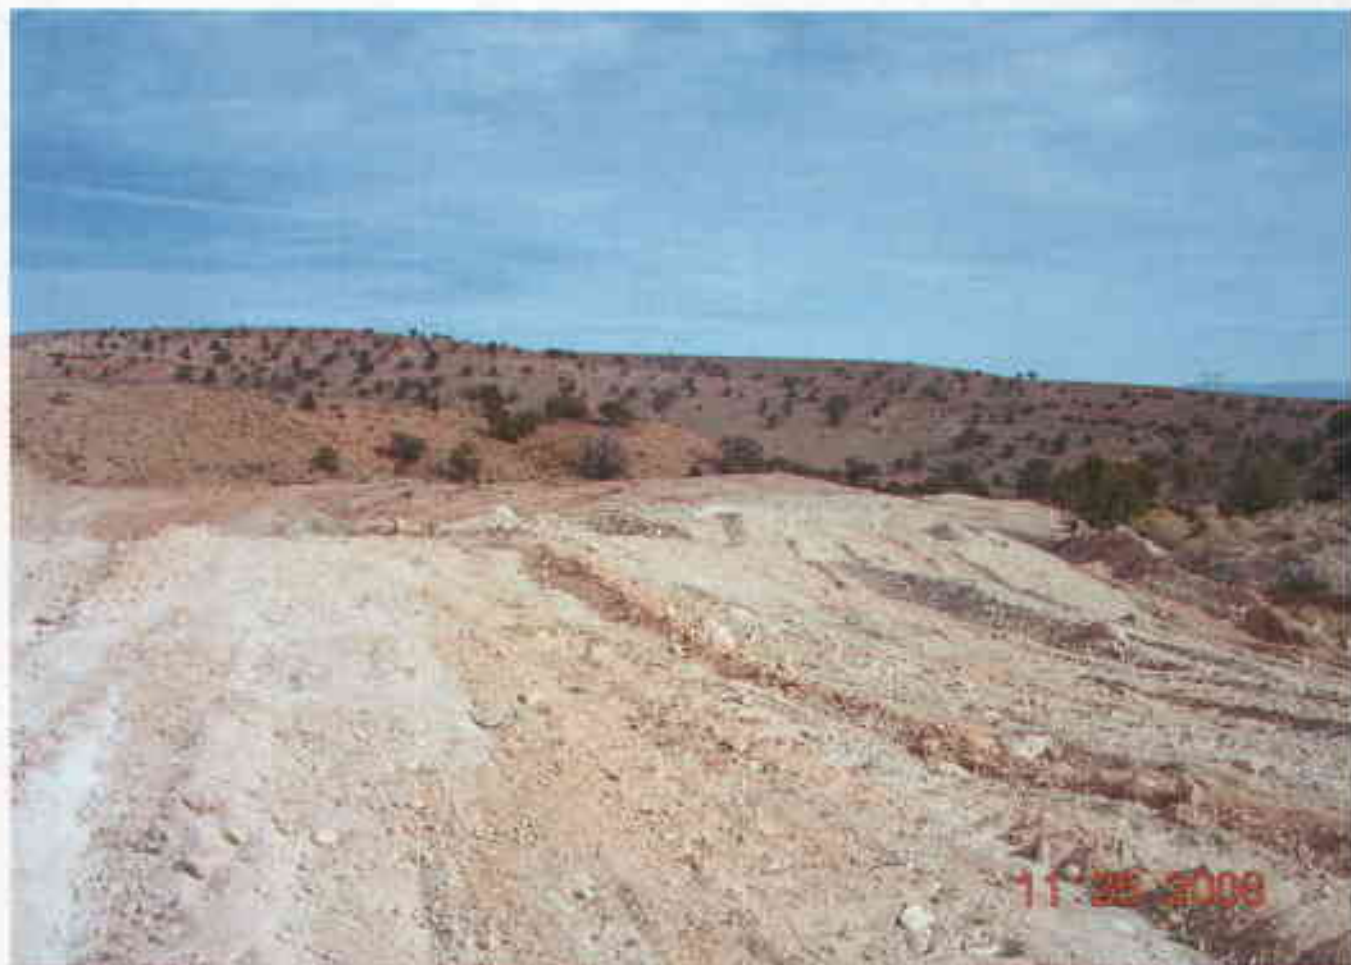
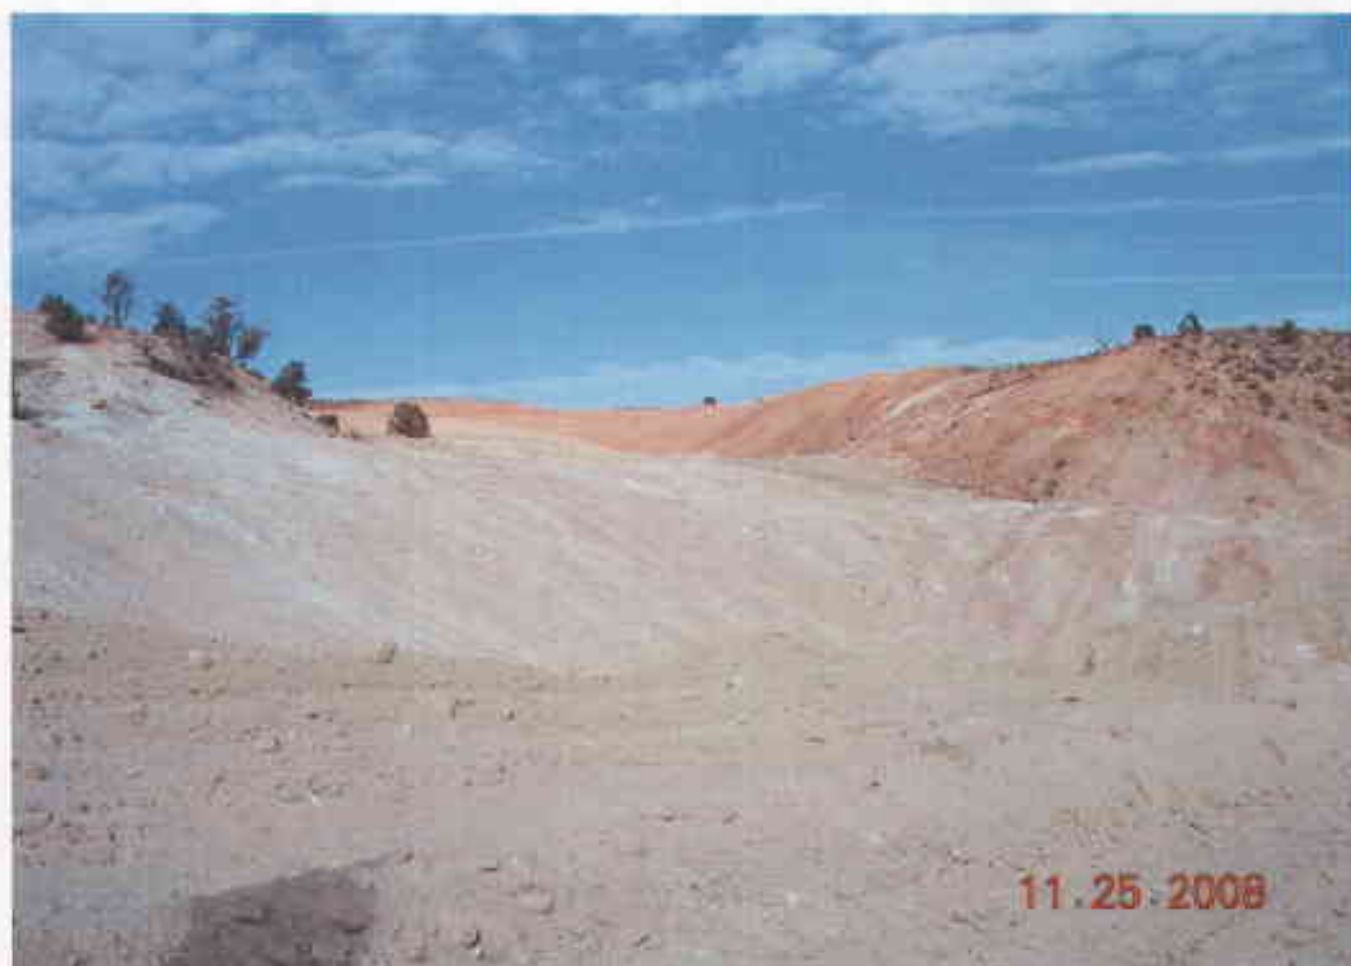
This site had been mined and abandoned prior to regulations requiring salvage of topsoil. Western Clay Company decided to reactivate the site in 2002. About 4,000 tons of clay were removed during the next three years. Reclamation of the site included regrading the area and backfilling the pit to the extent practical using old piles of overburden materials and cutting the highwall back. The operator will be seeding the disturbed areas within the next week. At the time of this inspection, most regraded slopes were less than 3h:1v, and blended into the natural surrounding topography. The operator was just finishing ripping the slopes to prepare the roughened seedbed.

Photos were taken to document site conditions.

Regrading work was acceptable and met DOGM requirements. Although the pit was not completely backfilled, it was backfilled more that was expected, given the limited amount of material on site to do this. The land owner indicated that his cattle can use any water that ponds in the pit like they did prior to reactivation. Once the area is seeded, the operator may request a partial release of the surety. Continue to monitor this site when in the area.
